# INDOOR AIR QUALITY ASSESSMENT

**Lowell High School  
1922 Building  
14 French Street  
Lowell, MA**

Prepared by:  
Massachusetts Department of Public Health  
Bureau of Environmental Health  
Indoor Air Quality Program  
August 2017

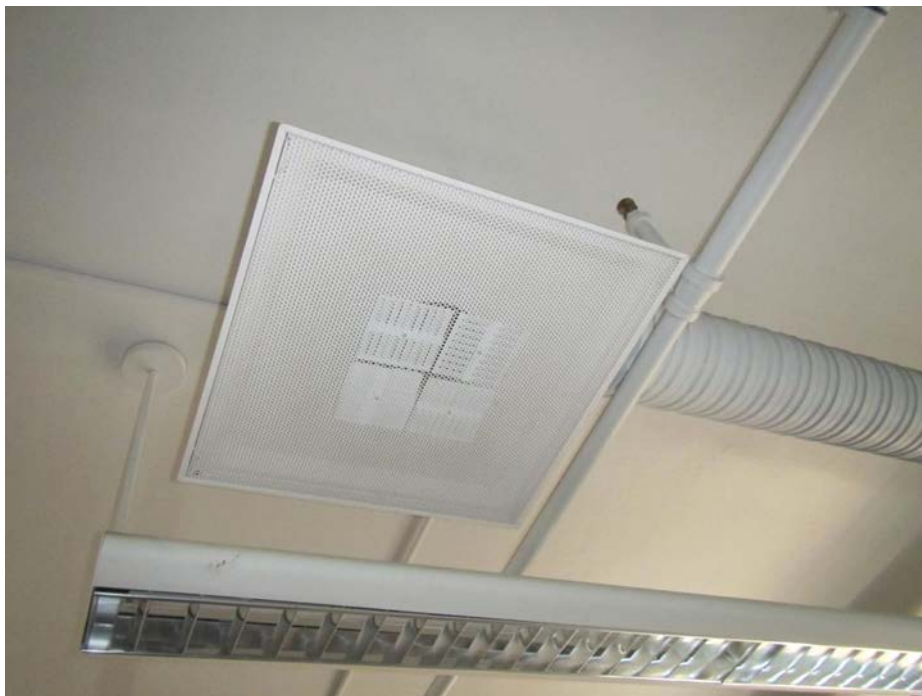
**Picture 4**

**Classroom supply air vent**

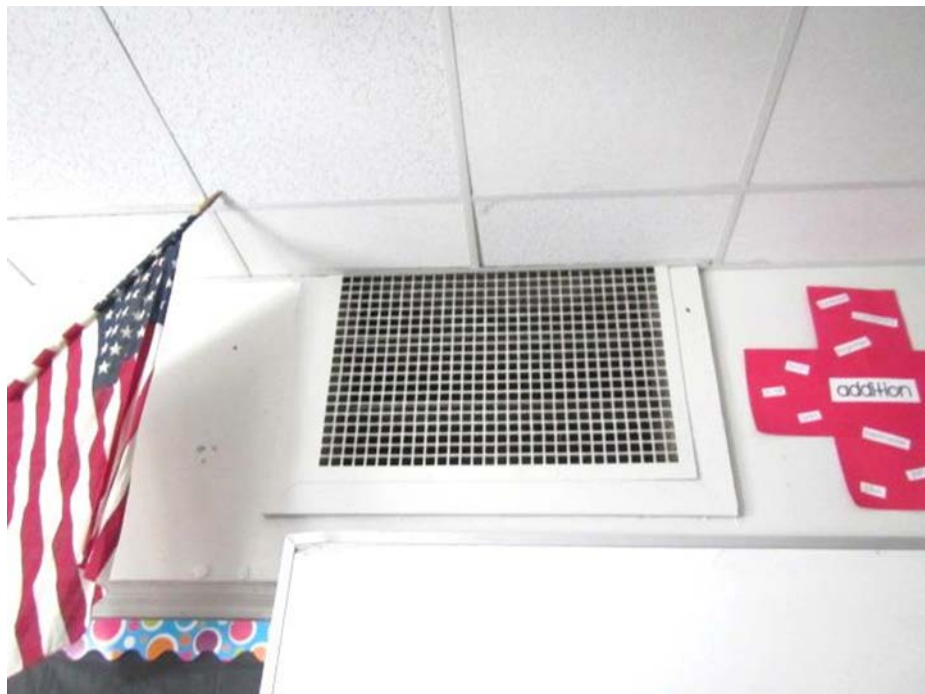
**Picture 6**

**Exhaust/return vent in classroom**

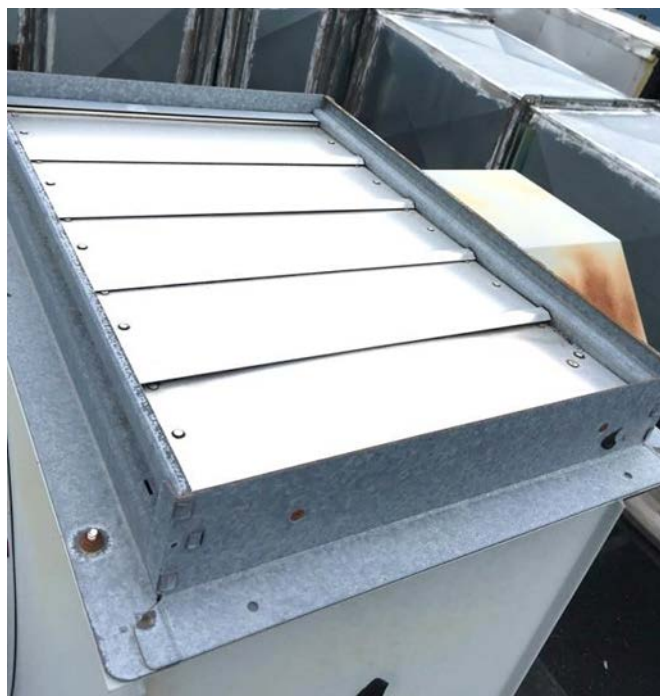
**Picture 16**

Usually a candy cane-shaped duct cap is installed over a louver system to prevent water accumulation.

**Exhaust duct louvers lacking “candy cane” vent cap**

7. Roof drains should be inspected regularly to remove any debris to avoid clogging/pooling.
8. Exterior HVAC ductwork should be inspected to find any missing or damaged insulation or unintended gaps which may allow moisture or pests to be introduced into the ductwork. Perform any necessary repairs. This would also include adding the “candy cane” vent covers to the exhaust louvers open to the elements.

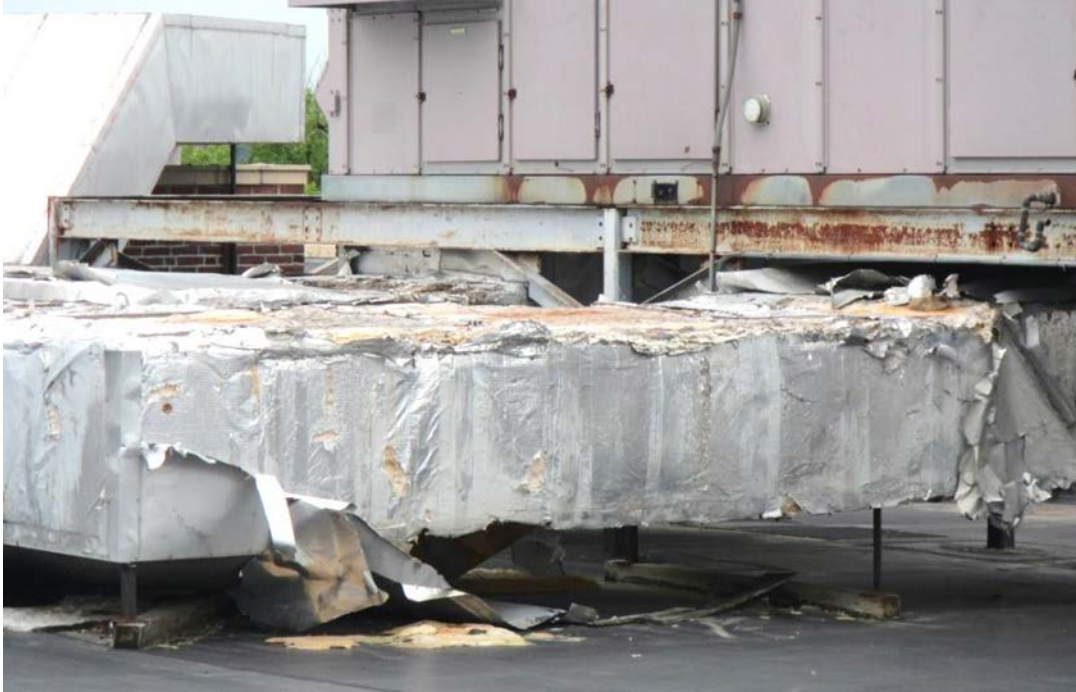
**Picture 17**

BEH/IAQ staff noted the ductwork insulation of an AHU to be badly deteriorated (Picture 17). This condition may allow water or condensation to enter the ductwork.

Deteriorating insulation reduce the capacity of the material to insulate.

**Deteriorated exterior duct insulation**

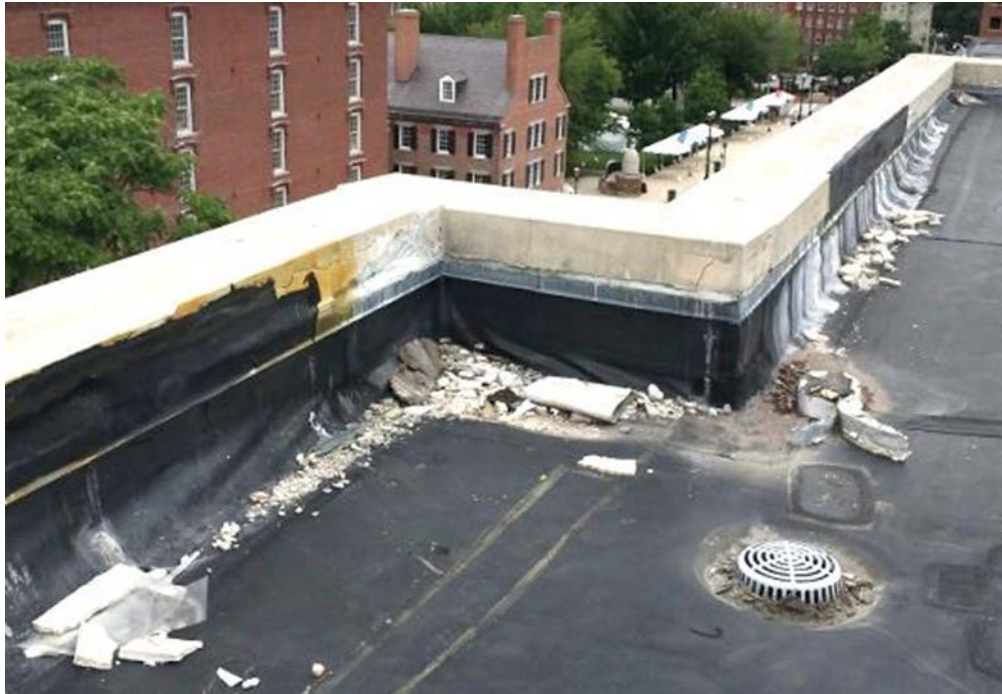
**Picture 19**

The roof in this area is flat with a raised parapet. The parapet itself was cracked and spalling with efflorescence above the roof membrane (Picture 19). Signs of chronic moisture issues (staining) were also visible along the front of the building below the parapet on the brick. These stains indicate damage is occurring to the parapet, roof, and façade of the building in this section.

**Evidence of spalling parapet and efflorescence**

9. Inspect and repair/replace any fresh air intakes that have missing or damaged bird screens or pre-filters.
10. Consult with a building engineer to inspect the building envelope to address any areas of water intrusion (e.g., windows, brickwork/mortar, flashing). This would include the brickwork noted with efflorescence and the spalling parapet.

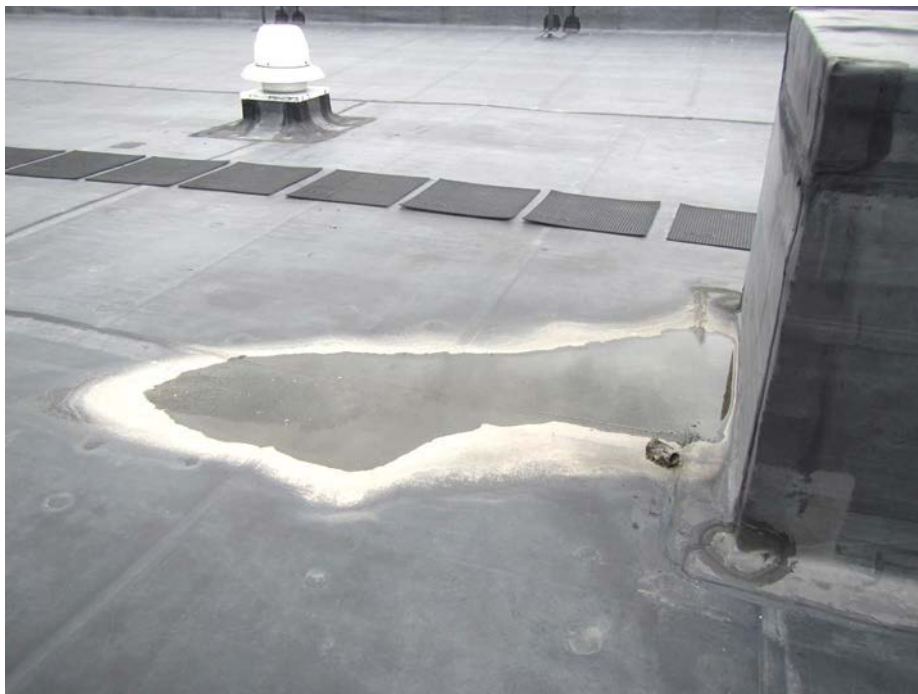
**Picture 20**

Note that the building has a complex shape with several levels of roof; roof seams were observed where exterior wall sections meet. Water from recent rains was observed pooling on some of the roof segments (Picture 20). This can lead to leakage inside the building once the roof membrane becomes damaged. Roof drains, roofing materials and flashing/connections between roof segments and walls should be examined regularly for pooling water and other indications of deterioration with repairs made as needed. Roof drains were clogged with debris in some areas (Picture 21). This condition will also increase the chance for pooling/leaks to occur. These drains should be cleaned regularly to allow for proper function.

**Water pooling on roof**

6. Consult with a roofing contractor to assess the roof membrane and underlayment/decking system. Repairs should be made to stop leaks and chronic water damage to building materials. The roofing system should then be monitored regularly for water pooling, leaks, and other deteriorating conditions.

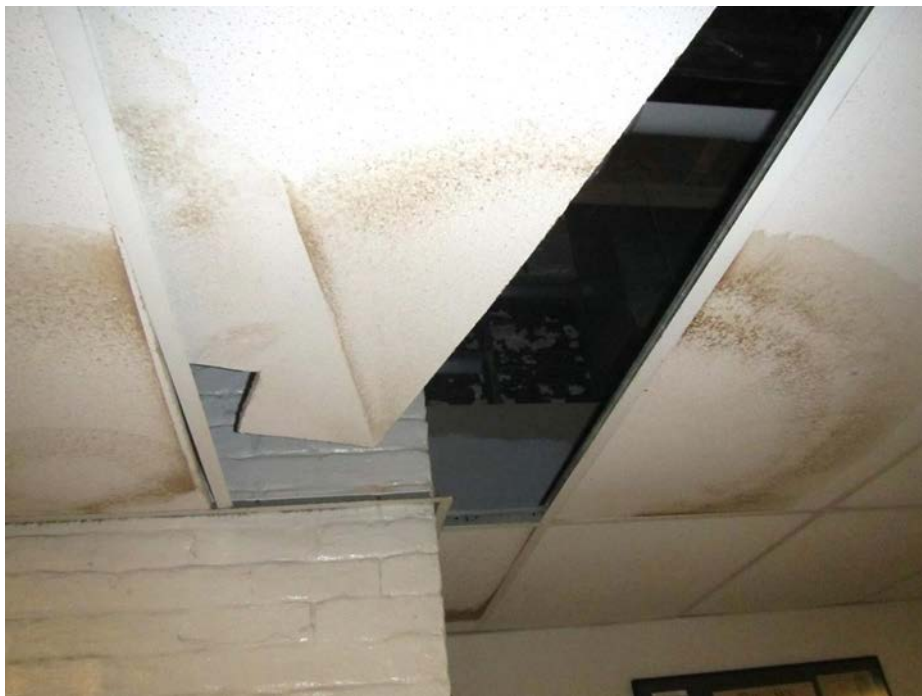
**Picture 22**

BEH/IAQ staff noted many areas with missing/ajar ceiling tiles (Picture 22). These ceiling tiles should be replaced to avoid serving as pathways to unconditioned areas.

**Missing ceiling tiles**

12. Replace any missing or ajar ceiling tiles to avoid pathways to unconditioned areas.
13. Consider adopting a balancing schedule of every 5 years for all mechanical ventilation systems, as recommended by ventilation industrial standards (SMACNA, 1994).

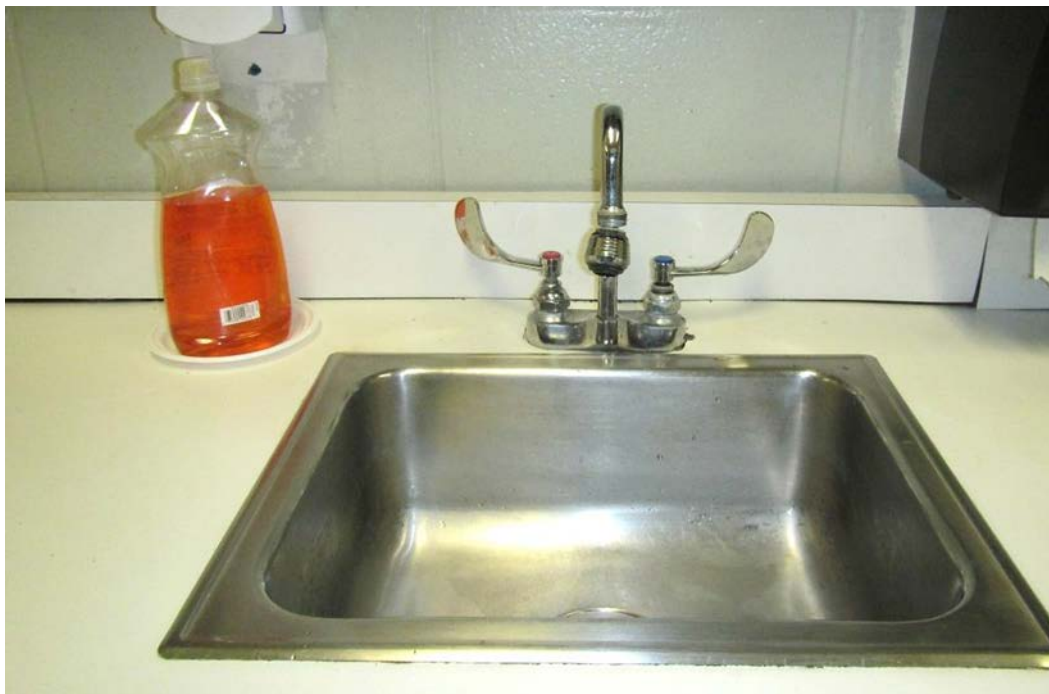
**Picture 24**

Sinks were observed in a number of classrooms. In a few areas, the backsplashes were unsealed (Picture 24). Some bathroom sinks were dripping and could not be shut off. Leaking plumbing can be a source of moisture to classroom materials and the indoor environment, particularly when outdoor humidity is high. Some sinks examined also had porous items (books, paper) stored inside the sink cabinet, which is a moist environment.

**Backsplash behind sink lacking caulking**

14. Ensure any plumbing leaks are repaired to avoid chronic water damage in the building.
15. Repair sinks and sink backsplashes in classrooms.
16. Regularly add water to any fixtures/drains that are out of order or are rarely used to avoid dry drain traps. Make necessary repairs or if fixtures are deemed unnecessary they should be properly abandoned and capped.

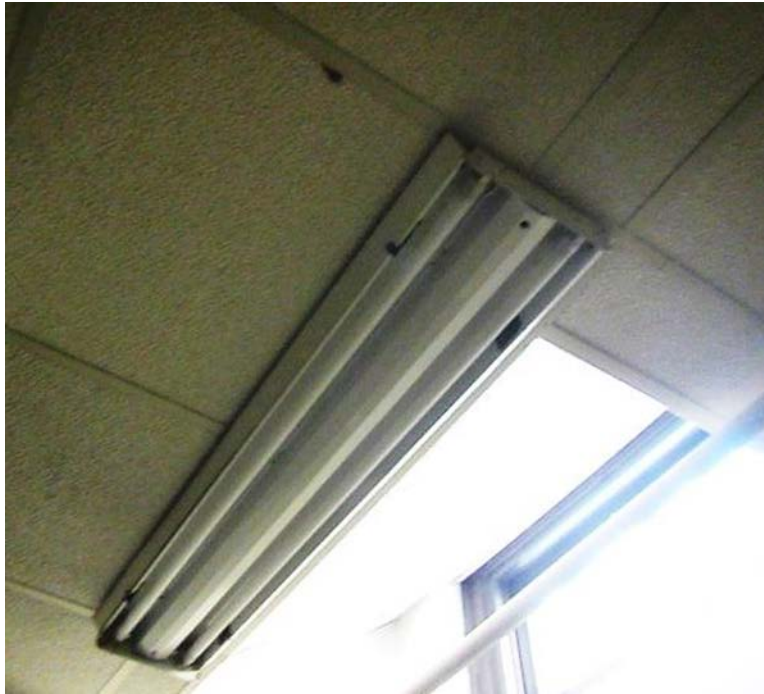
**Picture 25**

Missing/ajar light covers were seen in a few areas (Picture 25; Table 1). Fixtures should be equipped with access covers installed with bulbs fully secured in their sockets. Breakage of glass can cause injuries and may release mercury and/or other hazardous compounds. Other fluorescent lights had dust and debris inside them which should be cleaned.

**Missing light cover**

25. Replace/repair fluorescent light covers; ensure fluorescent lights are fully secured to prevent breakage and clean debris out of covers.
26. Encourage faculty to report classroom/building related issues via a tracking program.
